TECHNICAL BULLETIN 20230320

SEISMO VIBRATION/TILT SENSORS

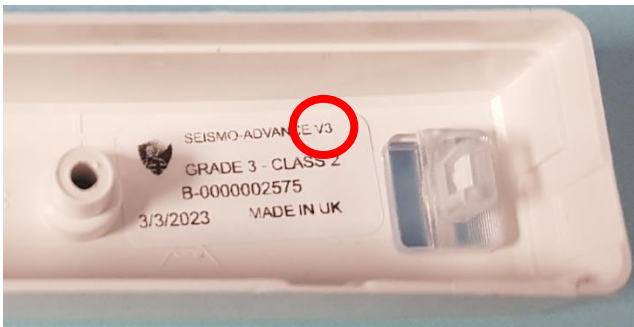
1. V3 marking on internal product label

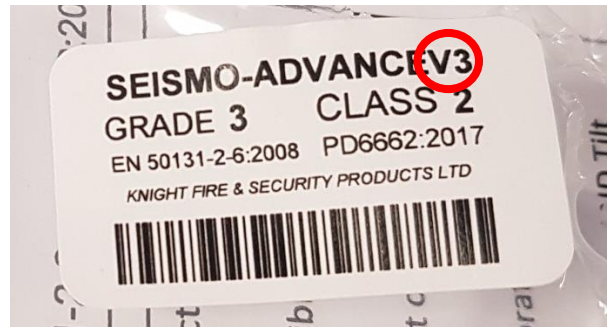
2. V3 marking on external packaging label

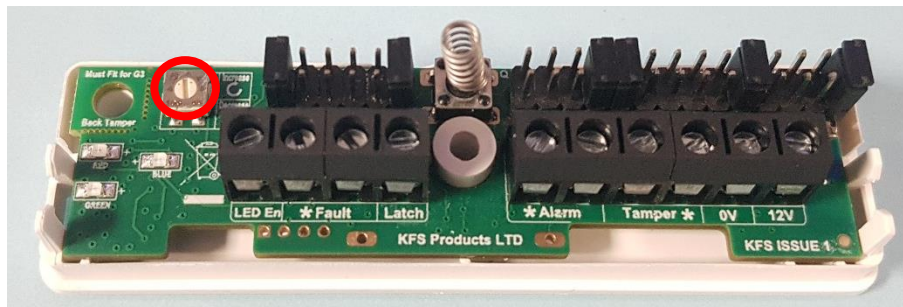
3. Square potentiometer on PCB

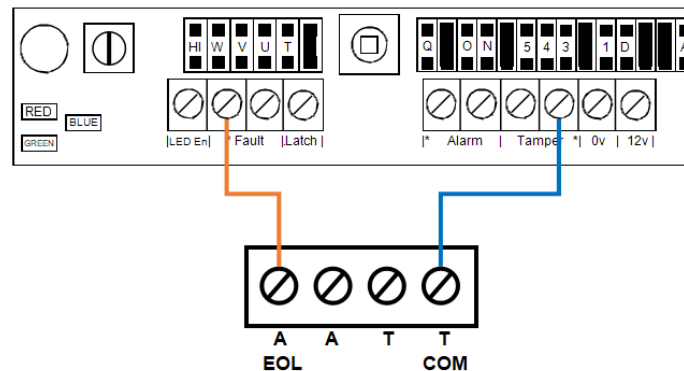
The root cause has been traced to a change to the specification of an onboard ESD protection diode - from bidirectional operation to unidirectional operation. This unidirectional ESD diode will abnormally affect the CIE reading of zone resistance if the polarity of the zone connection is reversed in respect to the diode.

Abnormal. Zone should read 2k2 secure but reads 3k5.

This issue is resolvable in situ without any need to return the product for repairs or modification. **A reversal of the zone connection wires will restore normal function if this problem is encountered.** See below examples of Pyronix TEOL (2k2/4k7/6k8) installations in both normal and abnormal states:

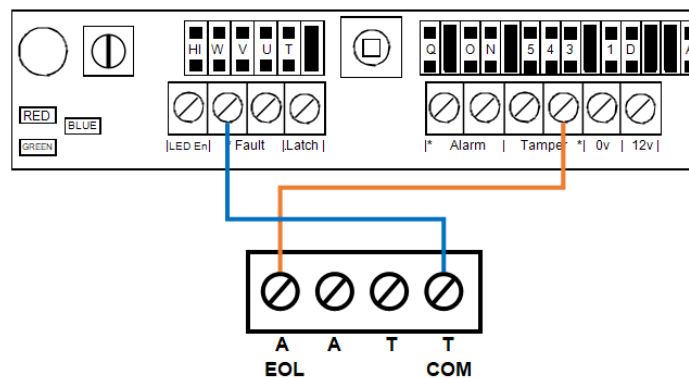
Normal. Zone reads 2k2 secure as expected.
